Smart Factory in Nantou with Highly Integrated Multi-system (Including Electronic Fence)

Site Name	Taiwan Copper Foil, Co., Ltd.
Country/City	Taiwan/ Nantou
Industry	Factory
Solution	DTV Integrated Service (Video + Alarm + Electronic Fence) DTV 1080P Digital Full HD Cameras P100 VMS
Solution Provider	Ubiquity Smart Technology Inc.
Reasons of Adoption	<ul style="list-style-type: none">■Retrofit without re-cabling■Cabling cost reduction■Long-distance transmission■Full HD video quality■Hybrid (IP/DTV) system■Other (system integration & low total cost)

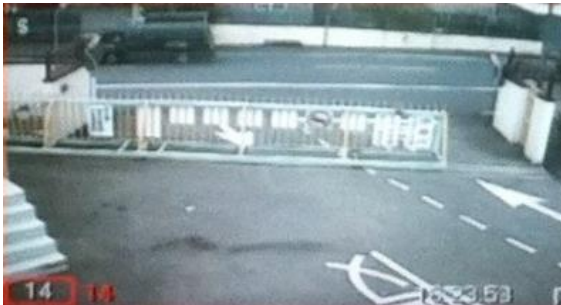
Figure 1. Comparison of before and after the upgrade.

(Before) image of CCTV cameras	(After) image of DTV cameras
Front Gate

Back Gate

Parking Lot	 	 
Periphery	 	 
License Plate No.	  <p>After zooming in the image, the license plate number is still unrecognizable</p>	  <p>After the zooming in the image, the license plate number can be clearly read as XX-4309.</p>

problems. UST found some potential problems. First, CCTV's video quality can only show the happening of an incident, but cannot provide any further detail, because it is difficult to identify the characteristics of the suspect or the vehicle license number from the blurry video. In addition, the colors of the clothes or the cars of the video may be different from the actual colors due to the environmental light. All these shall affect the direction of investigations once something happened.

The upgrade of video surveillance includes two parts. First, UST replaced the old and malfunctioned cameras with the new DTV digital HD cameras. Second, UST added additional cameras at the locations where the client requested, including the most important production line. The DTV full HD cameras installed there are for better production management. Because DTV products supports cable sharing, the signals from the newly installed cameras can be sent back to the 500-meter away control center using the existing cables, saving a great deal of re-cabling cost. The image to the fiber bus. The videos from several-dozen cameras all over the factory are further combined and sent to the control center through an optical fiber cable. The VMS system allows monitoring all channels from one single screen.

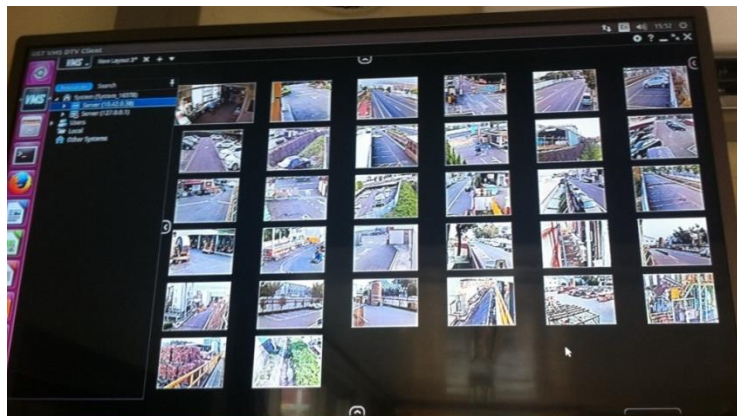
Figure 2. The two VMS systems have been integrated to be displayed on one single screen for convenient monitoring. Every camera has been linked to the alarming system. When an abnormal condition occurs, the system will give an alarm to notice the guards to check the image sent by related camera and make further decision.

UST improved the electronic fence by installing the fences fully surrounding the factory. They also introduce the DIDO devices in order to integrate the electronic fence system with the video surveillance system. When the infrared sensors are blocked and alarm is triggered, the related camera image will pop onto the screen and is zoomed-in. The system will also generate a sound to remind the guards to check the video to see if it is a real event or a fake alarm before rushing to the site.
